# **A Case Study into How Heritage Conservation and Green Building Technology Worked Together in One Victoria Home**

**Prepared for the Heritage Branch of BC and the Cascadia Green  
Building Council Sustainability Forum**

**November 2008**

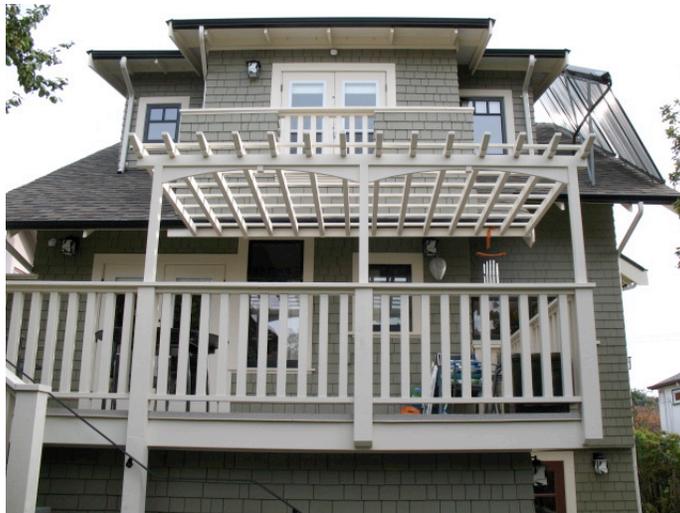
**Figure 8 - Back view (west); note solar panels on rooftop**

Likewise, new systems for geothermal heating, solar hot water, and Heat Recovery Ventilator (HRV) air quality control have been cleverly imbedded into the heritage structure to cause minimal damage to character-defining elements and zero visibility from either the pedestrian right-of-way or from main living spaces within the house.<sup>6</sup>

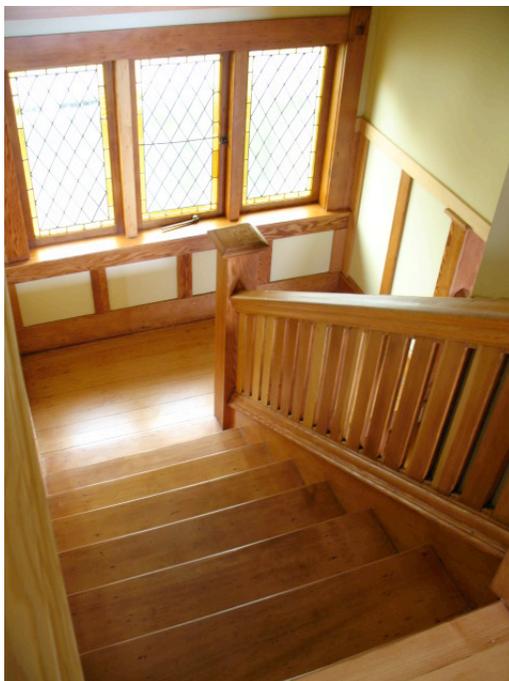
**Figure 9 - Fully restored 1910 staircase (from second floor)**

- 2) Interior floors, wood sideboards, pocket doors, trim and other wood details were all stripped to their original wood surfaces to reflect the Arts and Crafts aesthetic. While the floors, sideboards, and staircase could be restored *in situ*, wood trim had to be carefully removed, stripped, tagged, and replaced piece by piece.

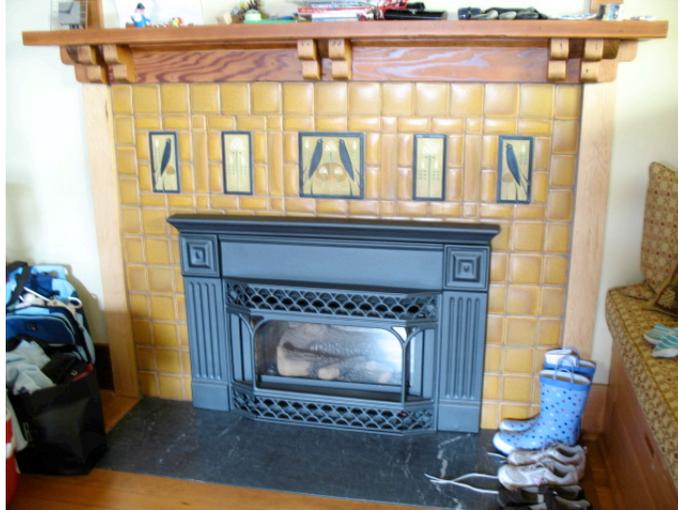
**Figure 11 - Restored Arts and Crafts fireplace in main entrance**

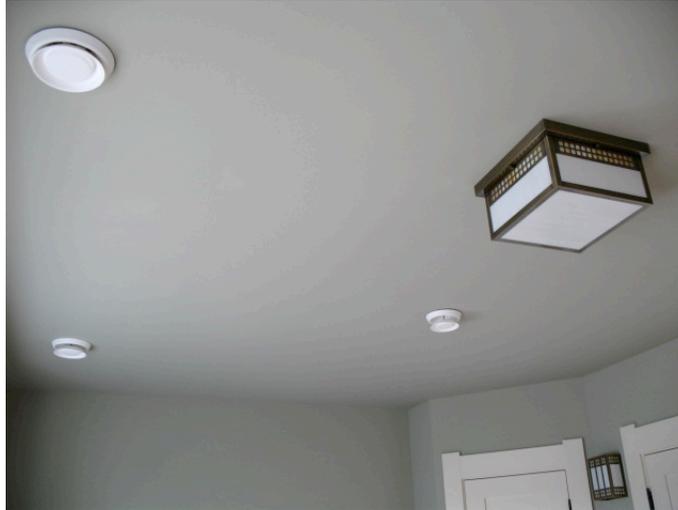
**Figure 13 - HRV supply vents, located on the ceiling of the second floor master bedroom**

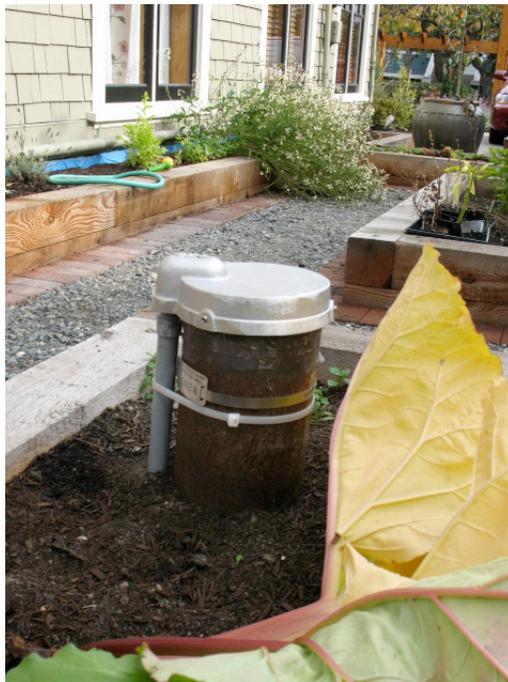
**Figure 14 - Geothermal well head (disguised by raised vegetable bed in south side garden)**
