# The Analysis of 1,000 Windows

# 1950's Public Building

GBCA  
ARCHITECTS

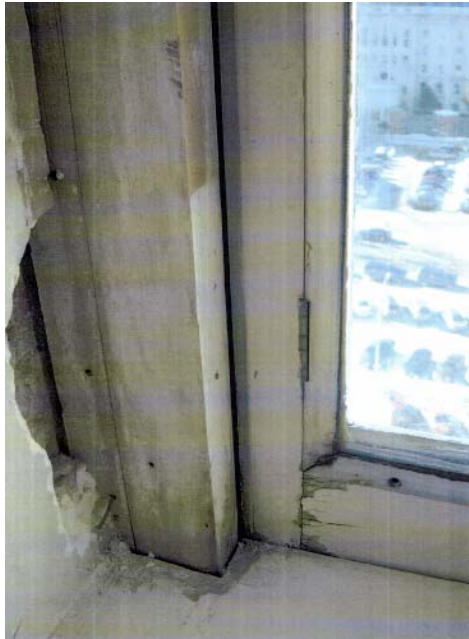
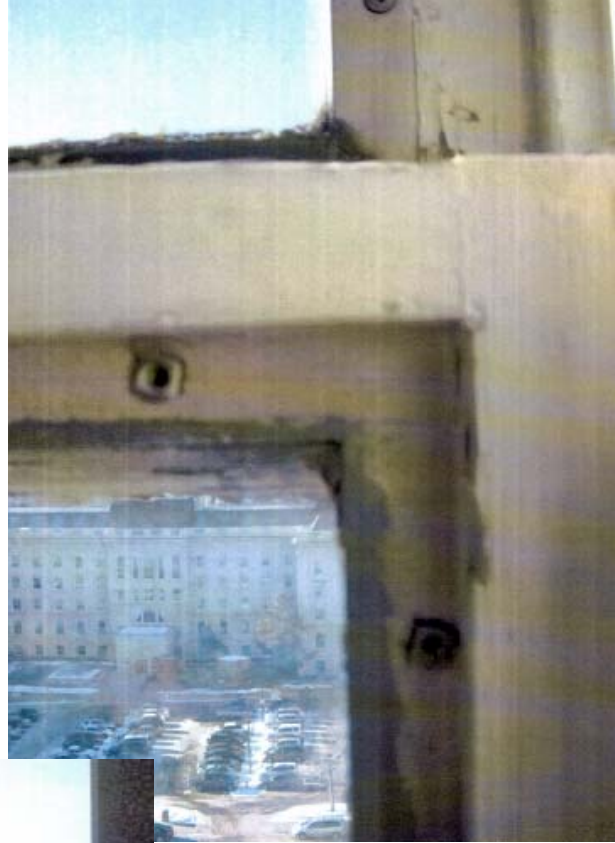
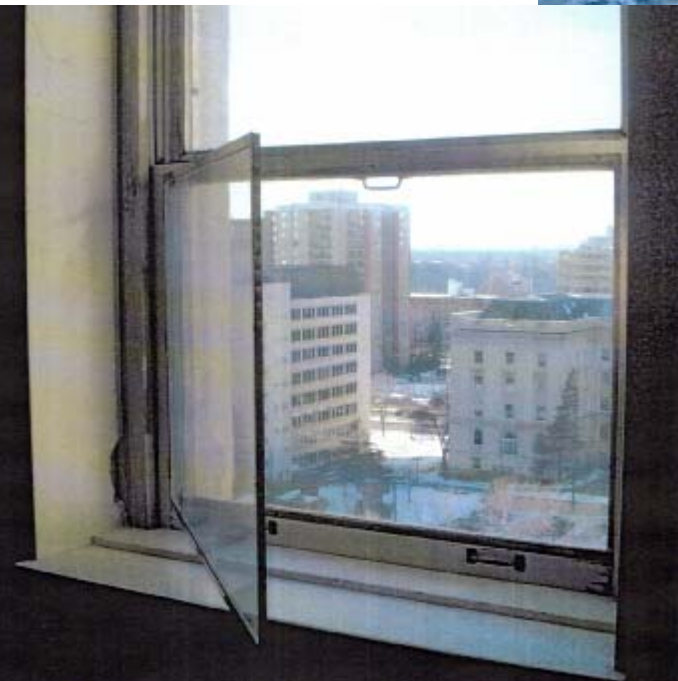
Windows were repairable. Of 1084 units, only 10 were in very poor condition

Original estimates suggested repairs to sash would be in the order of \$2,000 each. Final costs approached \$4,000 including removal and reinstallation

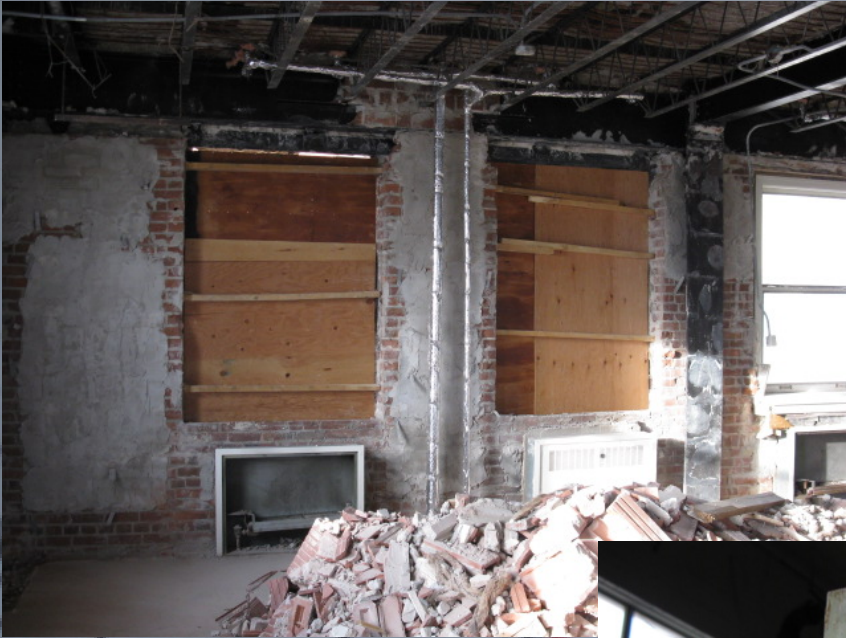
Detailed examination of all units

Removal of two units for testing removal and for mock-up repairs

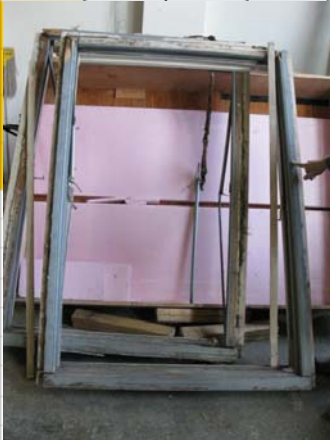
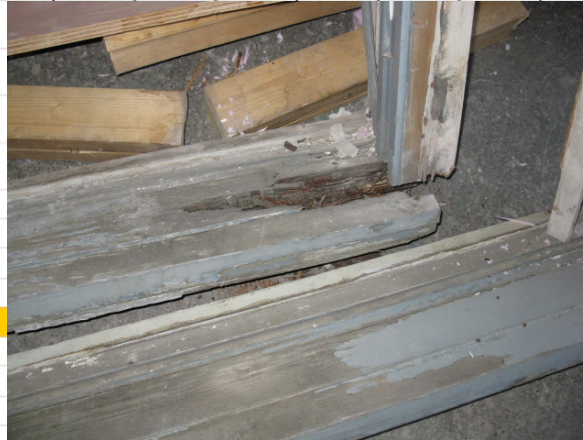
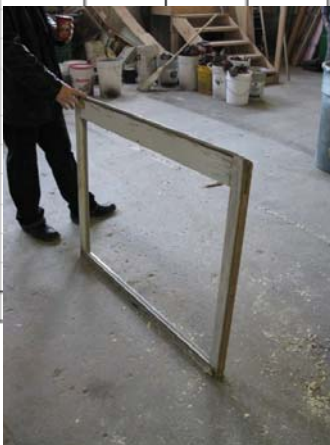
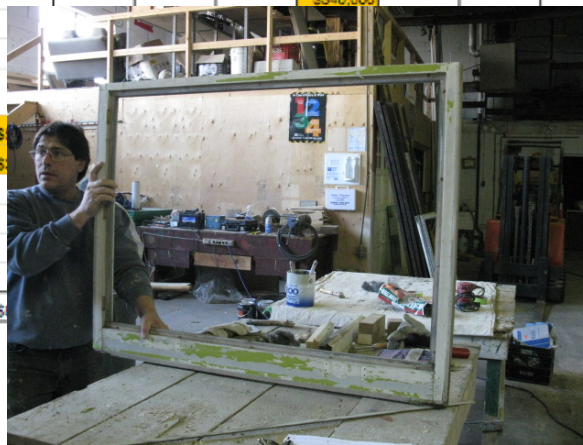
Repairs of two units (one sealed the other operable)

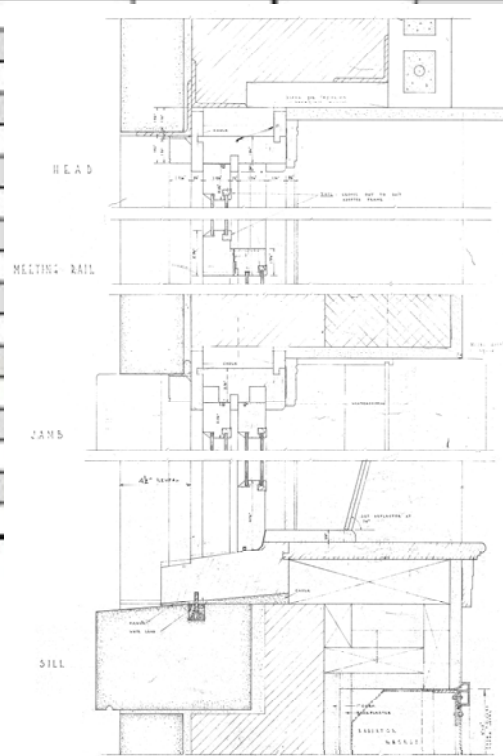
TYPICAL WINDOW DETAILS

Lower thermal efficiency than modern windows

Risk of hidden defects

Difficulty in connecting to exterior wall air barrier system
