# The Analysis of 1,000 Windows

# 1950's Public Building

GBCA  
ARCHITECTS

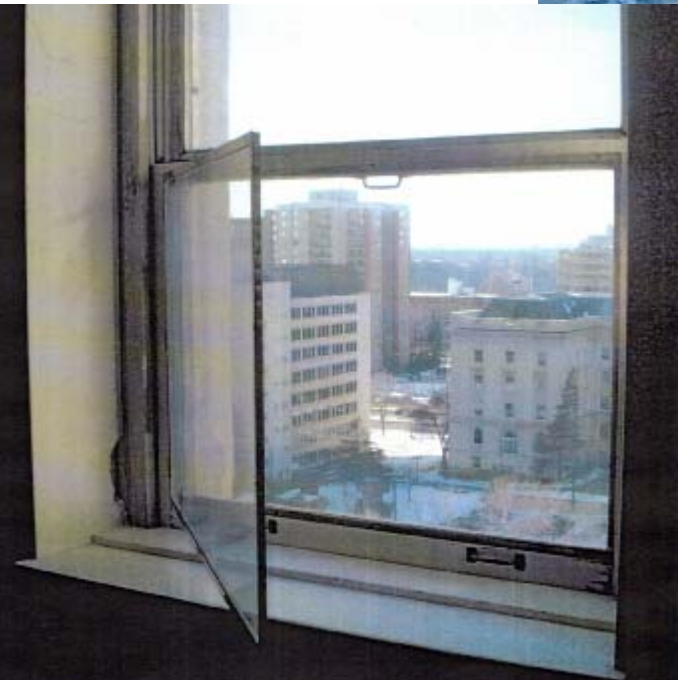
TEMPERATURE GRADIENT - OPTION 1 (EXISTING WINDOW ASSEMBLY)

Lower thermal efficiency than modern windows

Risk of hidden defects

Difficulty in connecting to exterior wall air barrier system
